Manhole Inspection Summary

Manhole # S47AA_043MH

Insp Date: **2/22/10 1:33 PM**

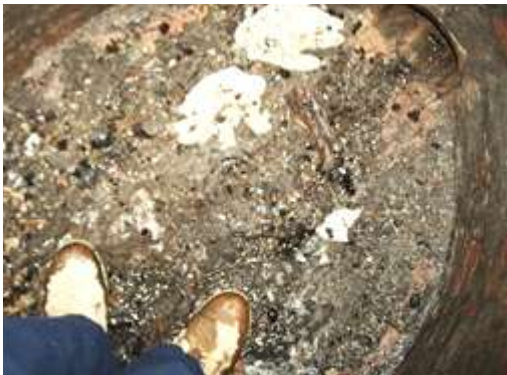
Defect 2

Condition: ☐ Sound ☐ Cracked ☐ Root Intrusion ☐ Deteriorated ☐ Leaks ☒ **Debris**

debris

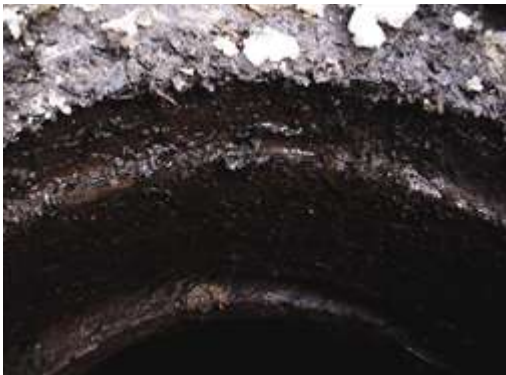
Defect 1

Frame Offset: **0** (in.) Condition: ☐ Sound ☐ Cracked ☒ **Leaks**

frame

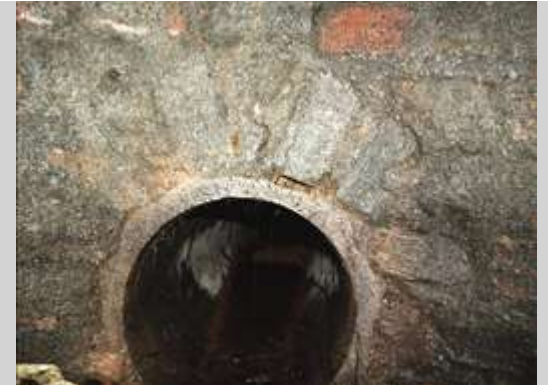
12 O'Clock Outflow

8 in. Circular Gravity Sewer
Pipe Out @ 12 O'Clock

Deposits: ☒ None ☐ Mud ☐ Sludge ☐ Debris ☐ Grease

Infiltration: **None** Pipe Seal Cond: **Sound**
